REPORT DOCUMENTATION PAGE		READ INSTRUCTIONS BEFORE COMPLETING FORM
1. REPORT NUMBER	2. GOVT ACCLSSION NO.	3. RECIPIENT'S CATALOG NUMBER
AD A092225		
4. TITLE (and Subtitle) Phase I Inspection Report Beaver Dam Lake Hudson River Basin, Orange County, New York Inventory No. 619		5. TYPE OF REPORT & PERIOD COVERED Phase I Inspection Report National Dam Safety Program

PHASE I INSPECTION REPORT
NATIONAL DAM SAFETY PROGRAM
BEAVER DAM LAKE
I.D. NO. N.Y. 619
D.E.C. #502
HUDSON RIVER BASIN
ORANGE COUNTY, NEW YORK

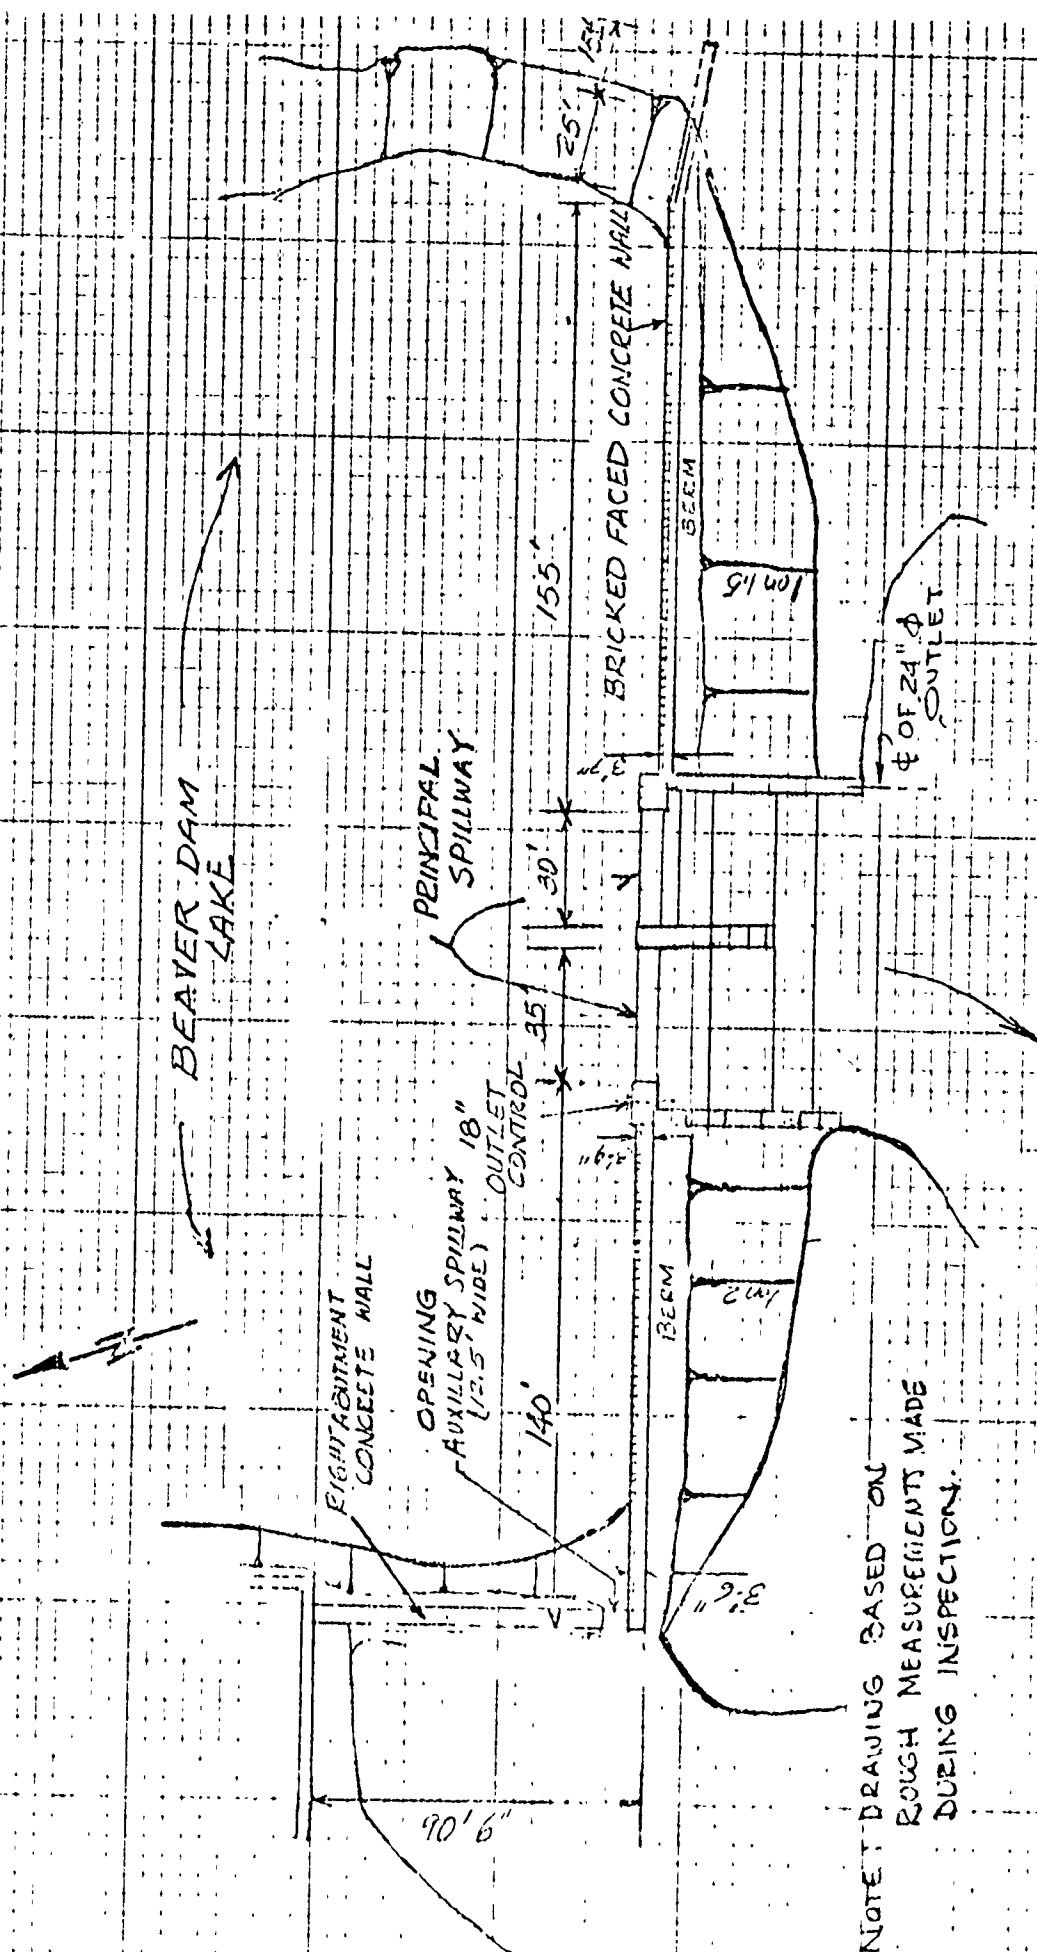
BEAVER DAM LAKE - PLAN
SCALE 1" = 50'

NOTE: DRAWING BASED ON
ROUGH MEASUREMENTS MADE
DURING INSPECTION.

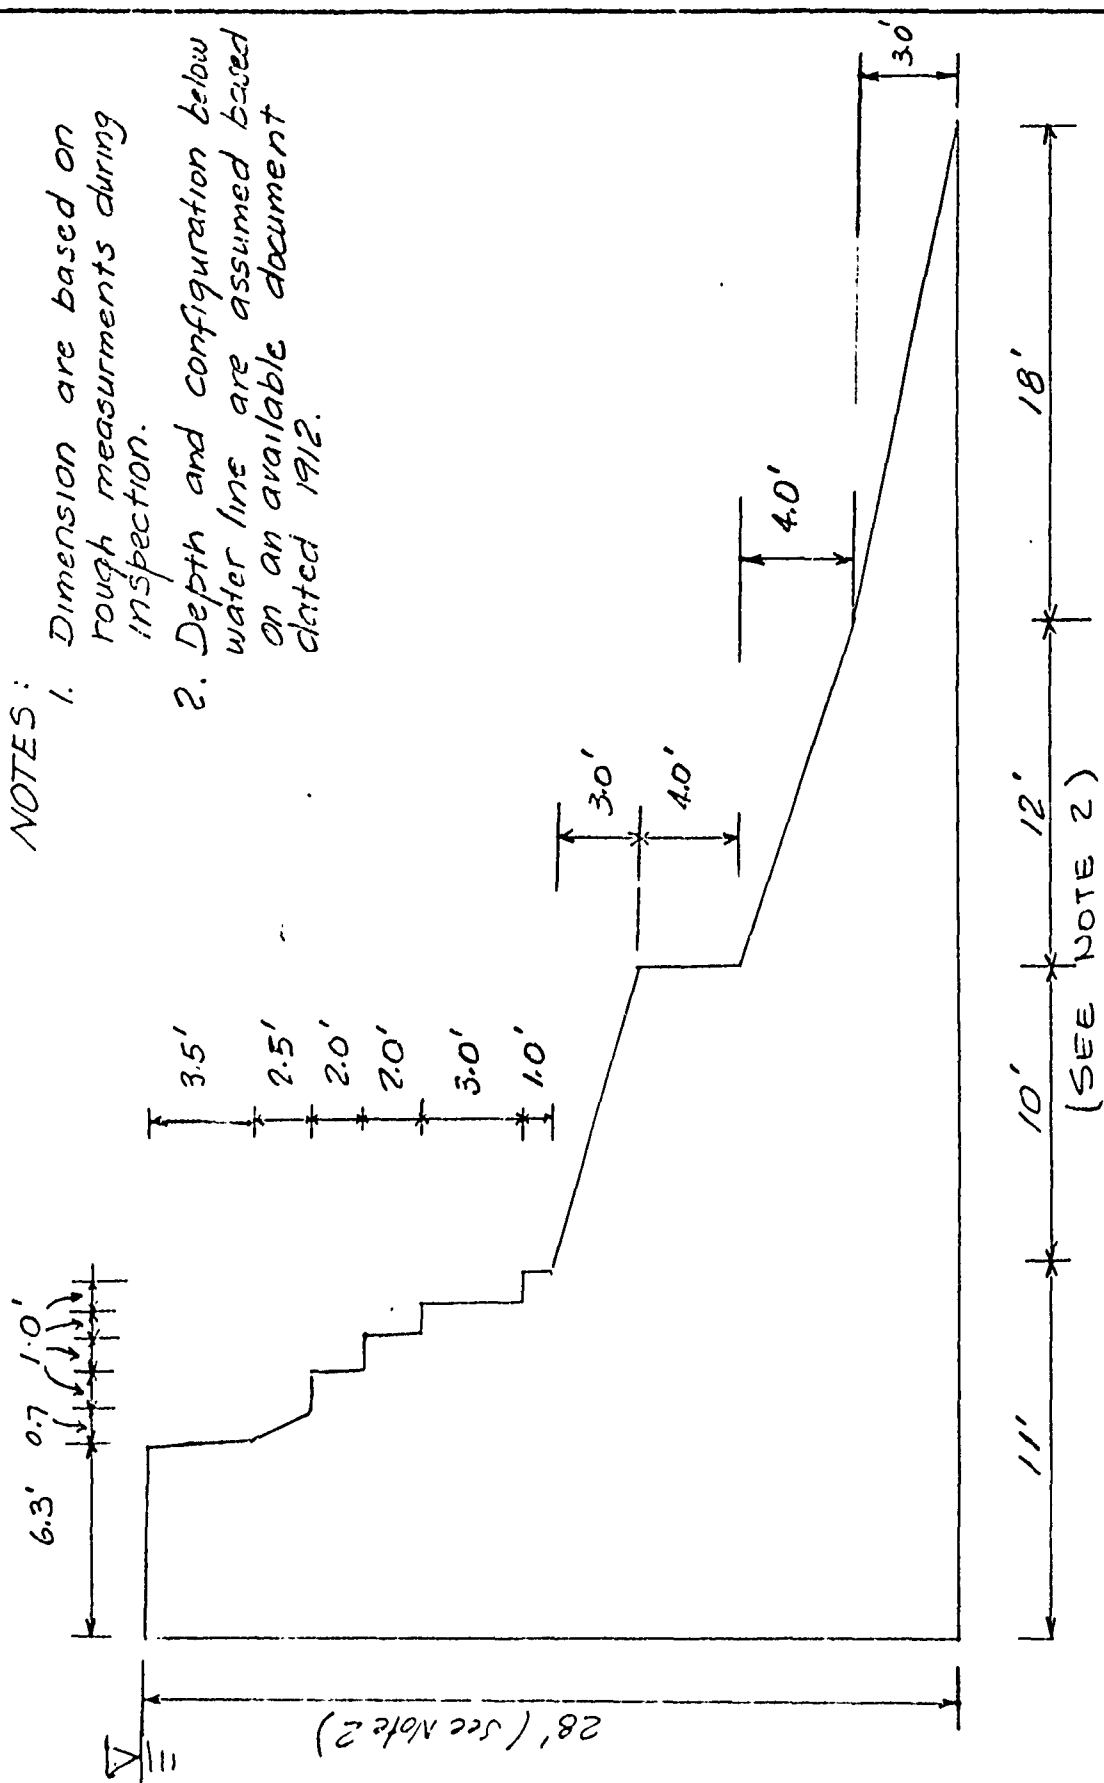
SECTION - RIGHT SPILLWAY SECTION

1. Dimension are based on rough measurements during inspection.
2. Depth and configuration below water line are assumed based on an available document dated 1912.

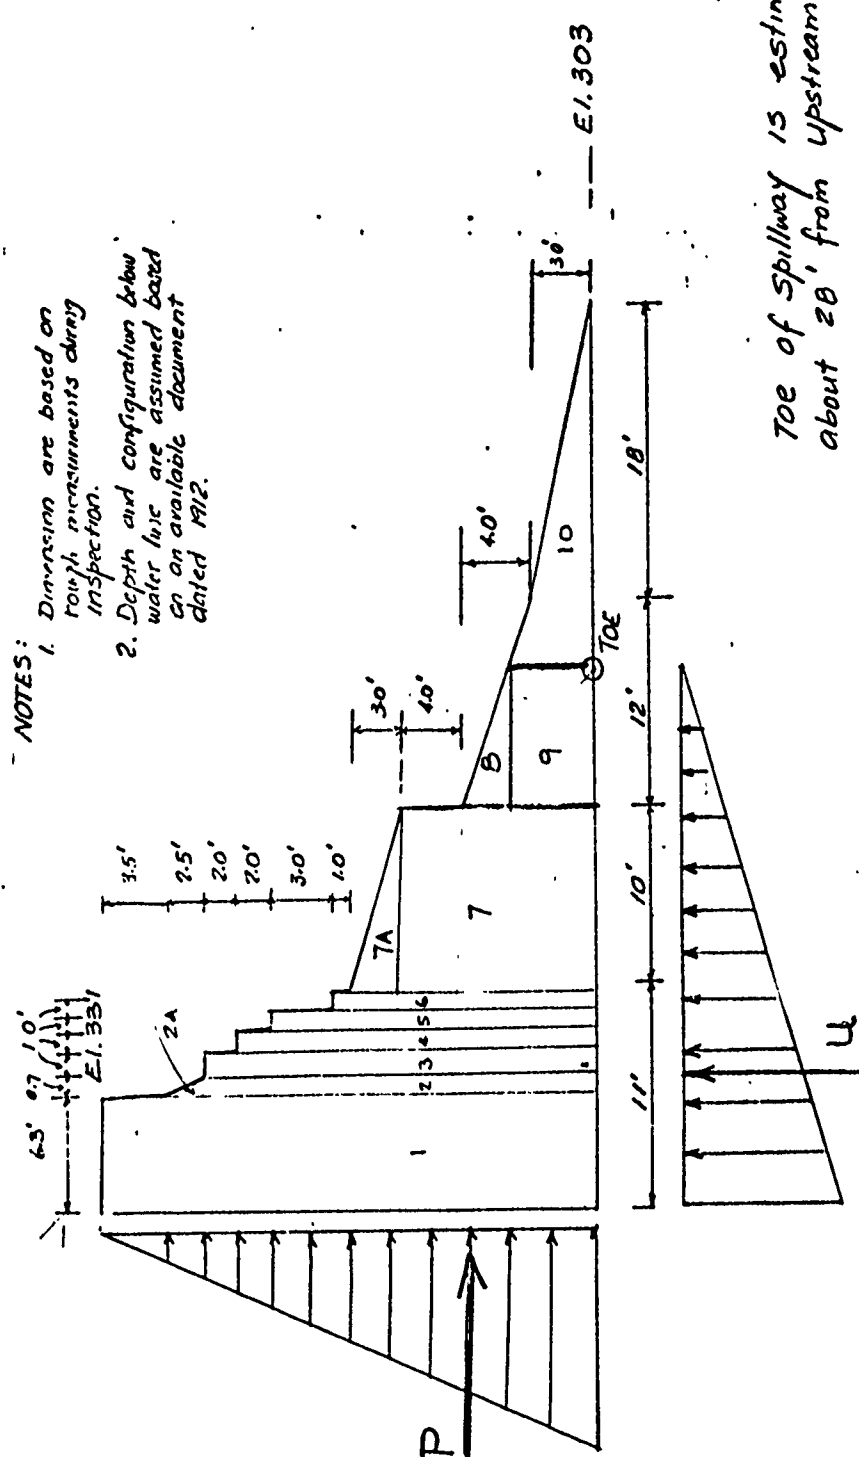
SPILLWAY SECTION

- NOTES:
1. Dimensions are based on rough measurements during inspection.
 2. Depth and configuration below water line are assumed based on an available document dated 1912.

Toe of Spillway is estimated at about 20' from upstream face.
